2021 National Atmospheric Deposition Program Site Survey Program Annual Report

U.S. Environmental Protection Agency
Office of Atmospheric Programs

Contract No. EP-W-18-005

February 2023

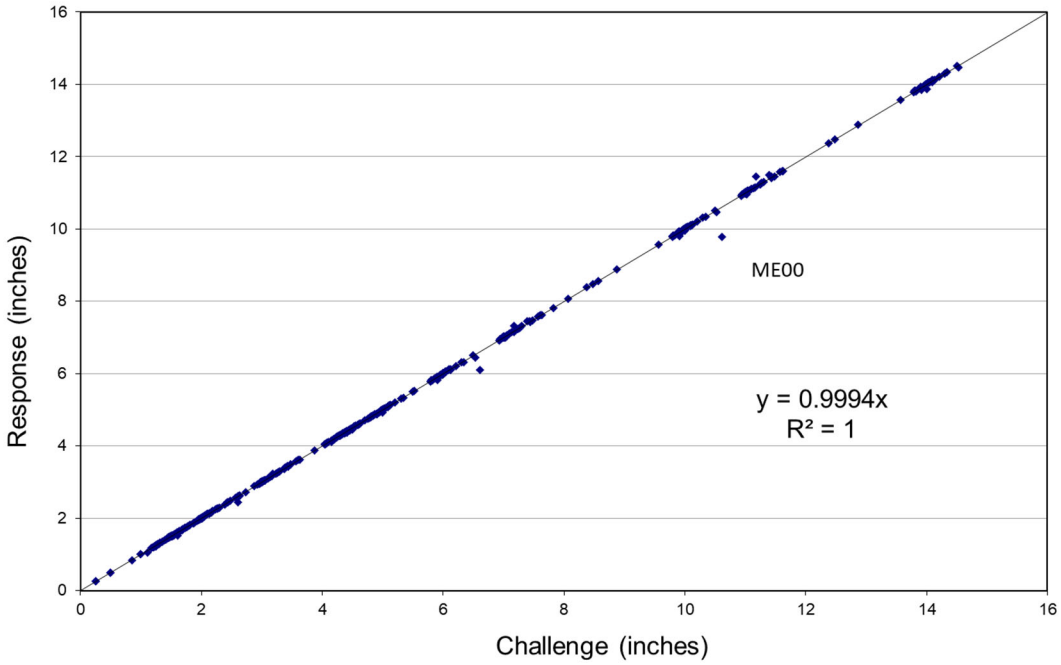
Figure 4-1. Electronic Raingage Accuracy – 80 Raingages

The results of the accuracy tests for the 80 electronic raingages challenged during the period covered by this report are presented in Figure 4-1. As demonstrated by the graph the raingages report the weight of the standards added very accurately for the entire span. The raingage for ME00 did not pass the initial test, but during the site survey the problem was resolved by uploading a new program. No other problems with the electronic raingages were encountered regarding the accuracy. Other issues encountered are discussed in Section 5.0.

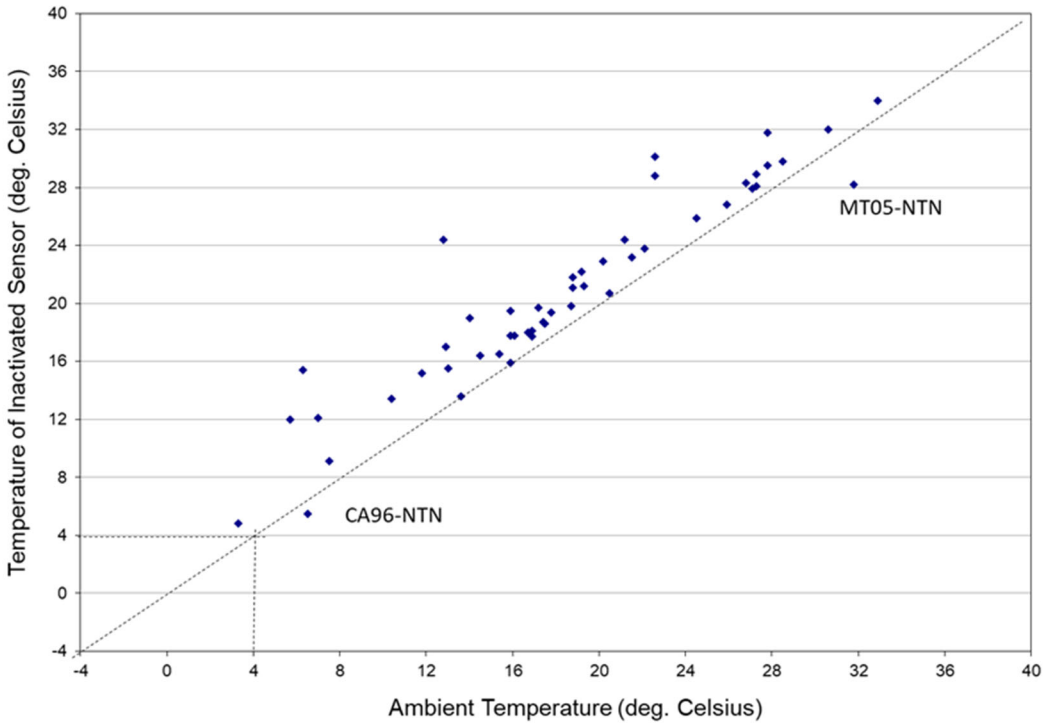
Figure 4-2. Inactivated ACM Sensor Temperature

The inactive sensor temperature tests are conducted using a thermocouple with the sensor shaded immediately after measuring the ambient temperature with the same device. The thin thermocouple is placed directly on the sensor plate between the sensor grids without making contact with the grid. The test results are presented in Figure 4-2. The results indicate that all sensor heaters were functioning properly except for one showing an ambient temperature greater than the inactivated sensor[3].

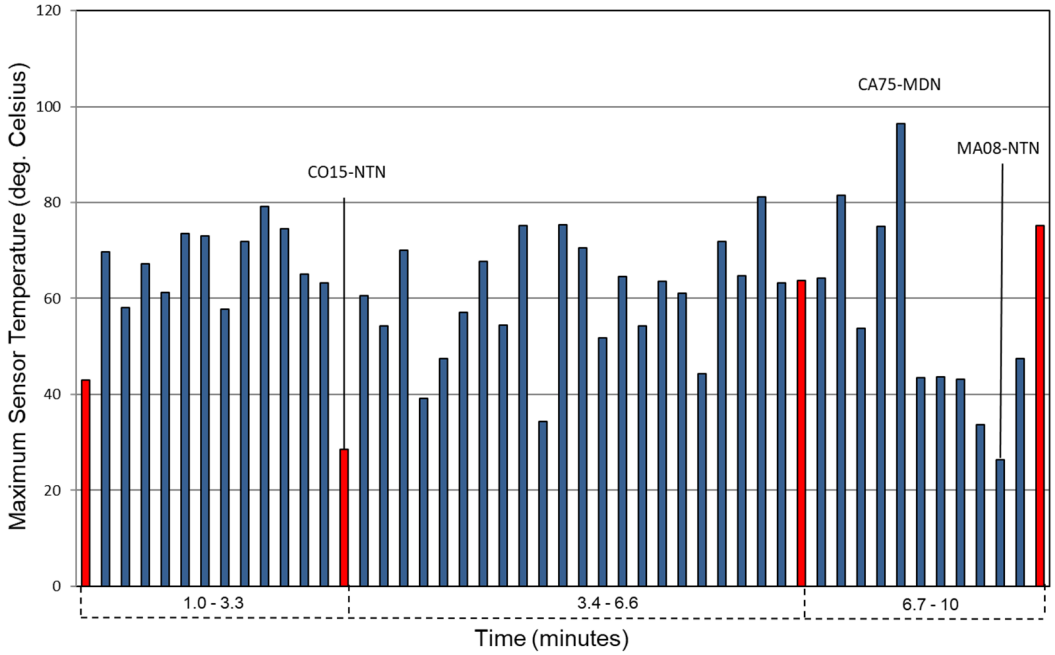
Figure 4-3. Activated ACM Sensor Temperature Increase and Elapsed Time

Figure 4-3 presents the maximum temperature reached by each sensor when activated, and the time required for each sensor to reach that temperature. There is some variability between sensors for maximum temperature, but most sensors are between 50˚C and 70˚C within 10 minutes of activation. Twelve sensors did not reach 50˚C, but most were reported to be functioning properly. The fact that the 50˚C mark was not reached may be due to windy and cool conditions at the sites. The red bars present in the bar graph highlight the beginning and end of 3.33-minute intervals.

Further evaluation of the data presented in Figure 4-3 is provided in Table 4-1, which includes the number of sensors that reached the maximum temperature within each 10-degree range above 30 degrees.

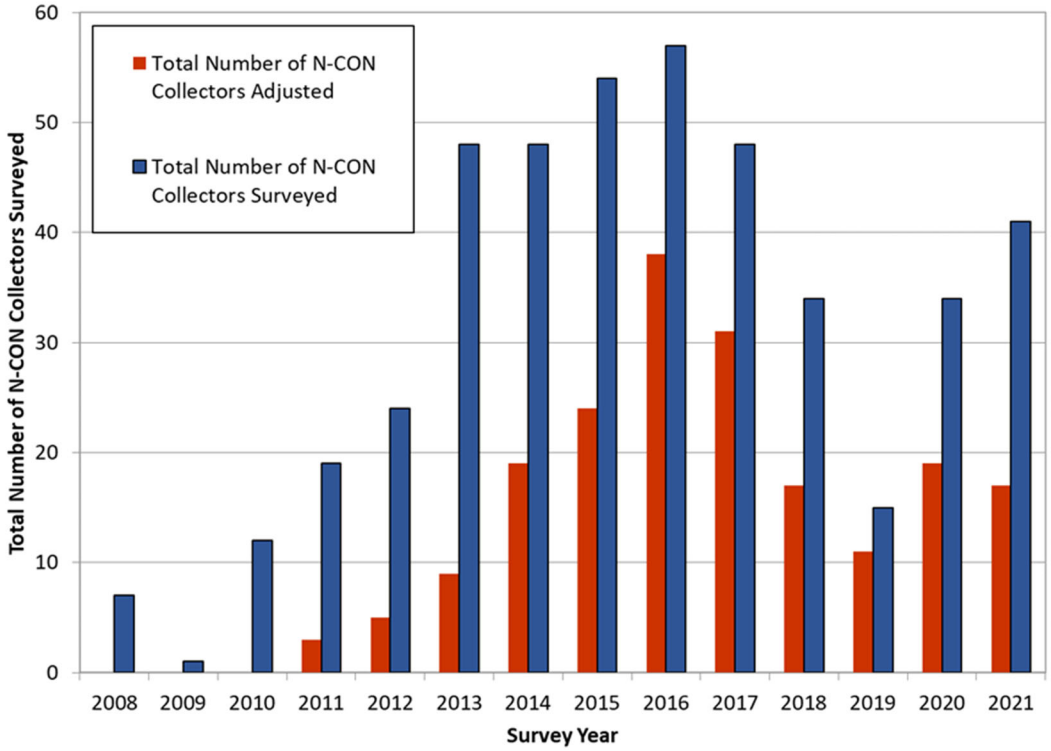
Figure 4-4. N-CON Collectors Surveyed and Adjusted per Survey Year

When collectors are found in this condition, they present a potential impact to data quality. Once lid arms are found to be loose, the collectors are flagged as having a “poor lid seal”. Proper lid seal is a direct indicator of data quality and therefore loose lid arms are an indicator of compromised data quality. Data collected since the introduction of N-CON single bucket collectors to the NTN network beginning around 2011 indicate that a very large percentage of collectors had a poor lid seal. Figure 4-5 is a comparison of ACM-type collector lid seal compared to the percentage of N-CON collectors that required lid arm adjustments. It is clear that poor lid seal condition increased with the introduction of N-CON collectors to the network. It can also be seen in Figure 4-4 that the number of collectors that need adjustment correlates with the total number of collectors observed. Some of the collectors visited have been adjusted and tightened during repeat visits, meaning that the initial repair with Loctite did not last between survey visits. This indicates the design flaw in the lid arms is likely to continue to be a problem with the collector going forward.

There is a recommended upgrade to the NTN N-CON collector that was installed at site WI36 a few years ago. The upgrade is a plastic spacer that is placed on the collector motor (inside the collector housing) and holds the motor more securely against the lid of the collector housing. The intention is to limit the movement of the motor when the collector is opening/closing which should in turn help to keep the sets screws from loosening. Site WI36 was surveyed in 2016 just after the the upgrade had been installed. This site was surveyed during 2020, and the arms required tightning, This is not the only site with the upgrade that has required adjustment of the arms. The upgrade may increase the length of time between adjustments, but it is not a pemanent solution.
